2023 34' 8" Aspen Power Catamaran C100

Pre-Purchase Report of Marine Survey

Date Of Survey: August 14, 2024
Report Submitted On: August 16, 2024

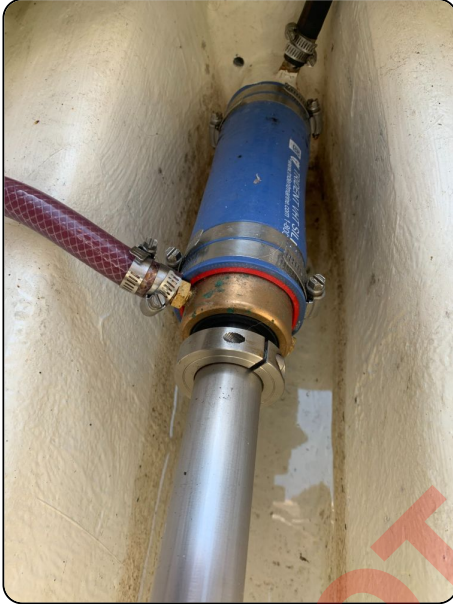
**Finding B-1**

Approximately 1/2" water was observed under the engine compartment propeller shaft with staining approximately 3/4" deep.

The water ingress or leakage source was not found during the survey/sea trial. The broker stated that the water was from the engine hatch leaking water from recent deck washdowns. Investigate further, and mitigate as necessary.

The water ingress or leakage source was not found during the survey/sea trial. The broker stated that the water was from the engine hatch leaking water from recent deck washdowns.

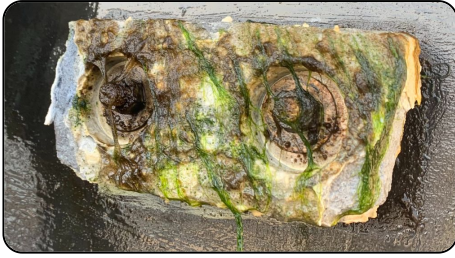
**Finding B-2**

The starboard side transom zinc was approximately 35% waisted.

Monitor and replace, as necessary.
