Condition & Value Report of Marine Survey

2007 31' Catalina 309 Fractional Sloop

Conducted By
Cpt. Mark Van der Vliet

Date Of Survey: January 16, 2024

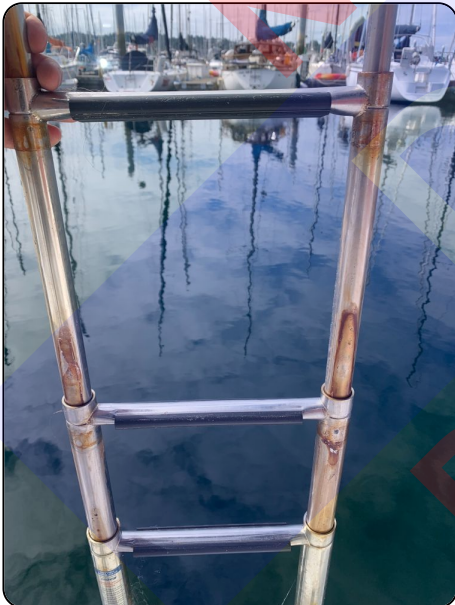
**Finding B-1**

The swim ladder has developed slight corrosion (rust).

Refinish or replace the ladder, as necessary.

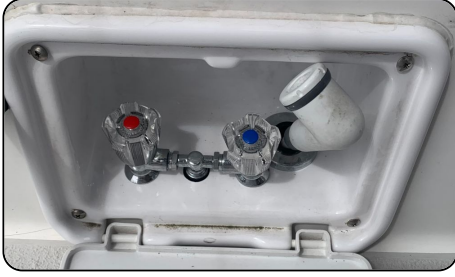
Finding B-4

The shower nozzle had broken/missing hardware.

Investigate further/trace, and service, repair or replace as necessary.

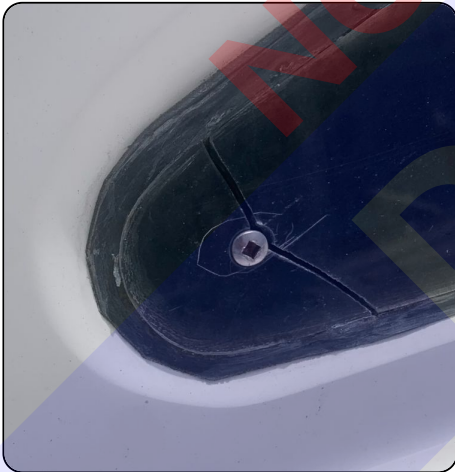
Finding B-5

The port window had a small crack at the forward fastener.

Refit, repair or replace, as necessary.

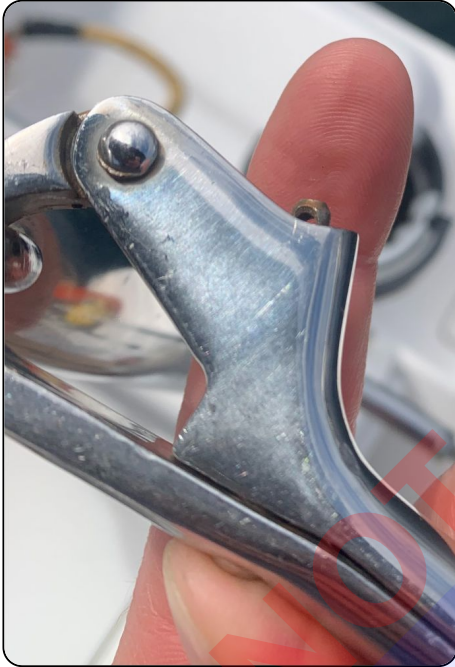
**Finding A-1**

The upper walk-through transom wire gate shackle pin was missing its pull-ring, and could not be opened

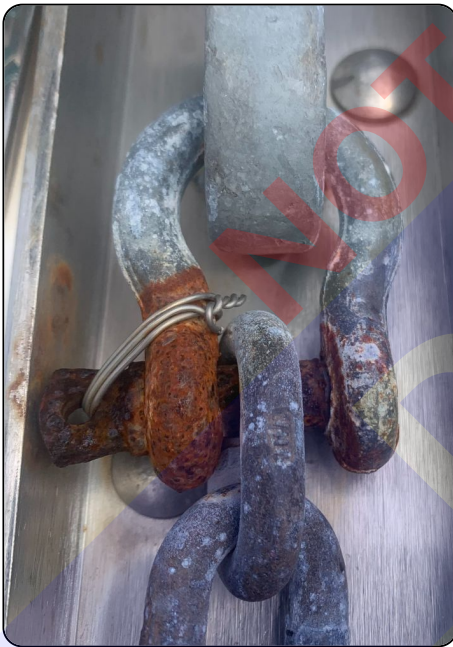
Finding A-3

The anchor-to-chain shackle was corroded/rusting.

Replace the shackle.

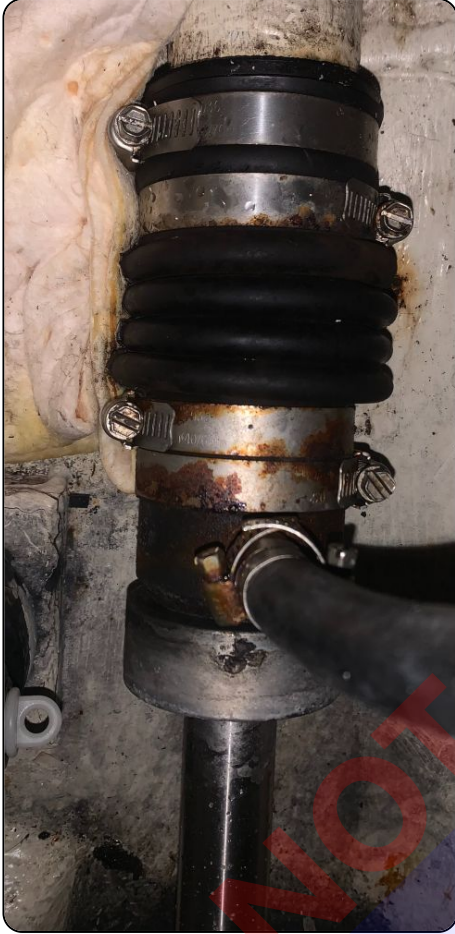
Finding A-4

Several of the vessel's hose clamps on the shaft seal boot have developed general rust.

Inspect all hose clamps and clean/treat or replace with doubled marine grade stainless steel clamps where appropriate, as necessary.

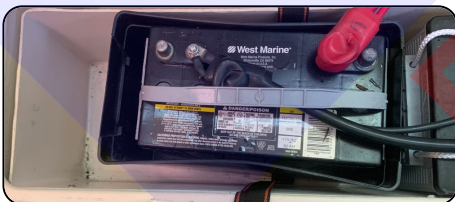
Finding A-5

The start battery was not well secured.

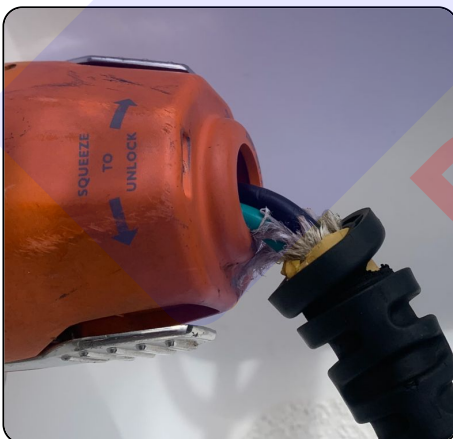
Finding A-6

The AC shore power cord's inlet plug was pulled adrift at the boot.

Repair (if this can be done in accordance with good marine electrical practice) or replace the shore power cord, as necessary.

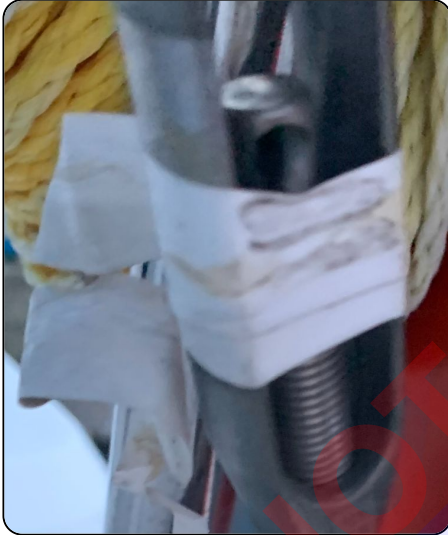
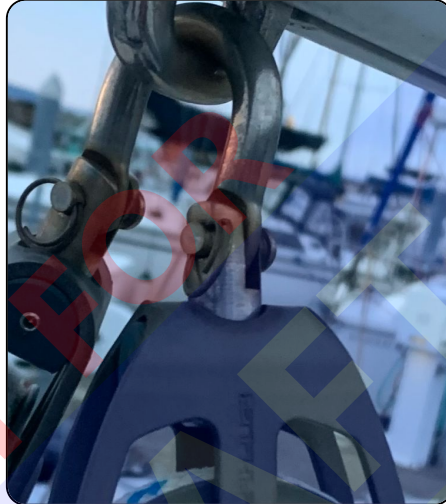
Finding B-8

The mainsheet starboard swivel block on the boom has a clevis pin with a ring that is separating.

Replace ring.

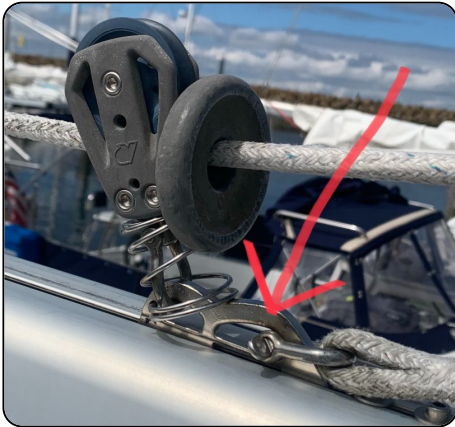
Finding C-2

The mainsail outhaul shackle pin was not secured with seizing wire.

Recommend securing pin with seizing wire.
