2023 34' 8" Aspen Power Catamaran C100

Pre-Purchase Report of Marine Survey

Date Of Survey: August 14, 2024
Report Submitted On: August 16, 2024

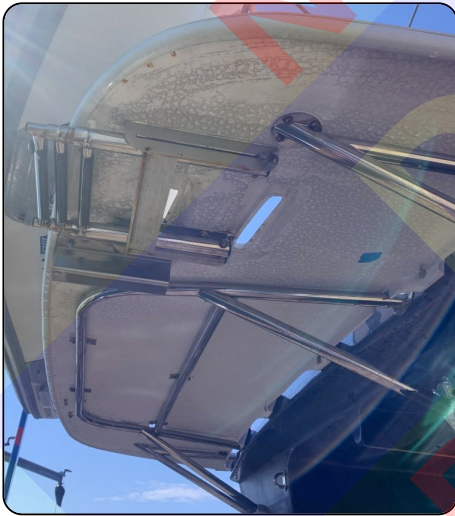
A telescoping stainless steel boarding ladder was installed under the aft starboard side of the swim platform. The boarding swim ladder was inspected and found to function as intended.

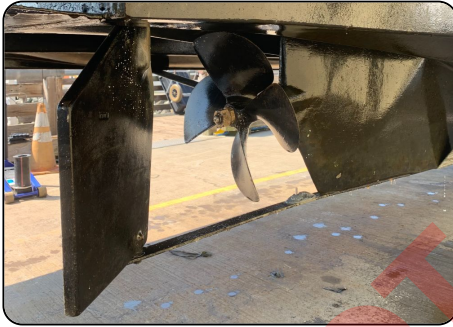
No cavitation erosion, dents, or damage was observed on the blades and no play was observed between the hub and shaft. The nut and cotter pin were securely fit.

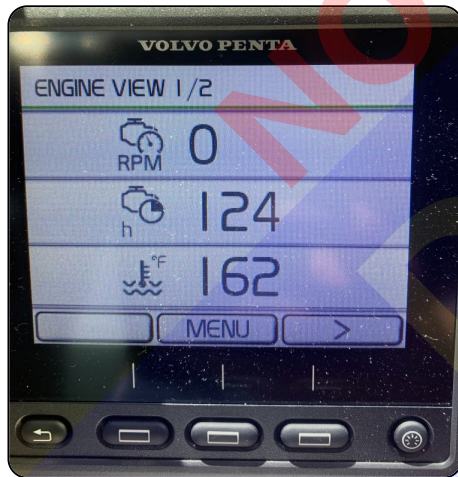
124 hours were observed on the Volvo-Penta display's digital hour meters.

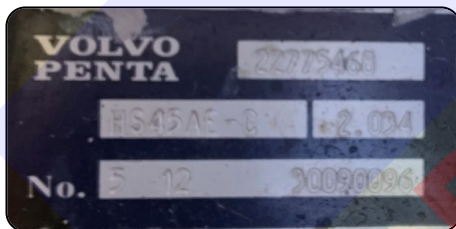
Normal level was observed on the transmission dipstick.

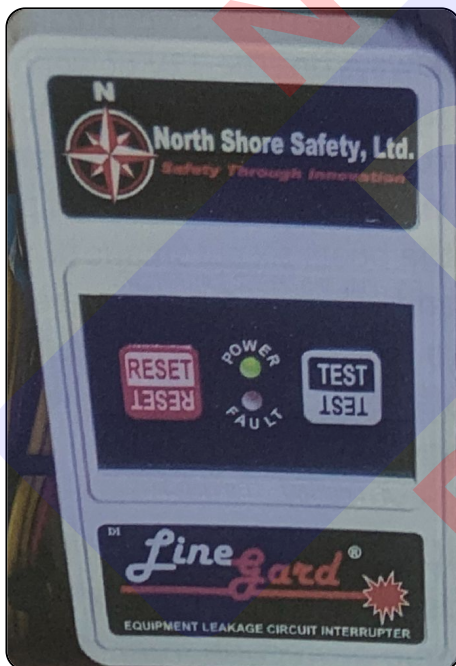
The AC outlets in the head, dinette, and helm appeared to be conveniently located. The vessel system GFI is located behind the dash above the forward stateroom berth. Demonstrated.
